APPENDIX 8.7
Stability Assessments 2007 and 2010
TOBIN Consulting Engineers

SRAHMORE PEAT DEPOSITION SITE

STABILITY ASSESSMENT

December 2007

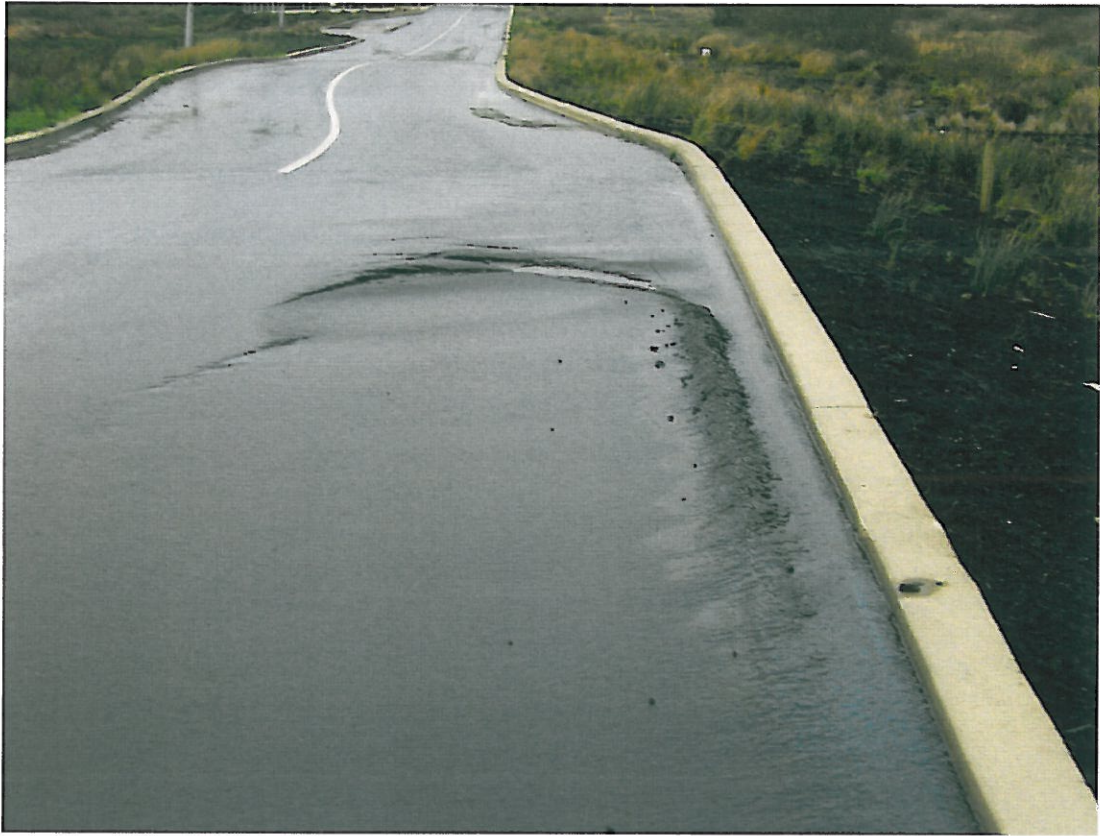
Cracks and localised wheel ruts are evidence of damage to the wearing coarse were present particularly on the east side of the road.

Localised cracks and rutting Haul Road

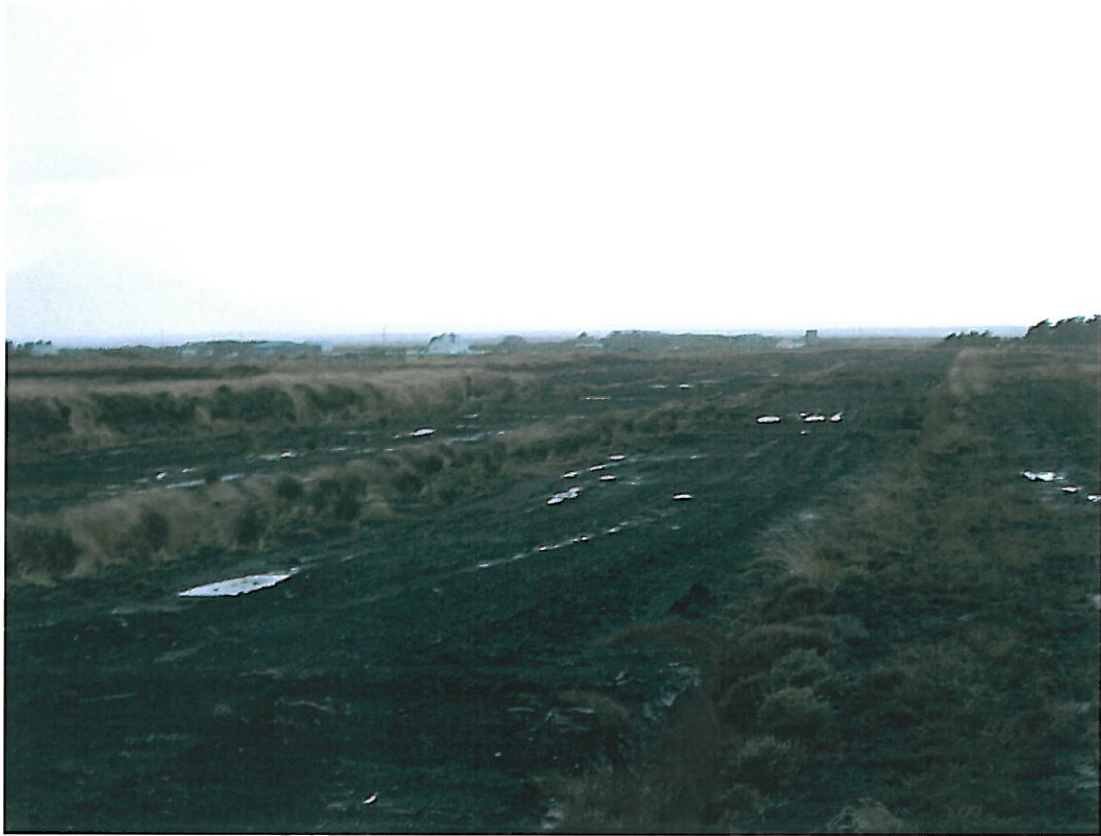
Bay 1 Empty

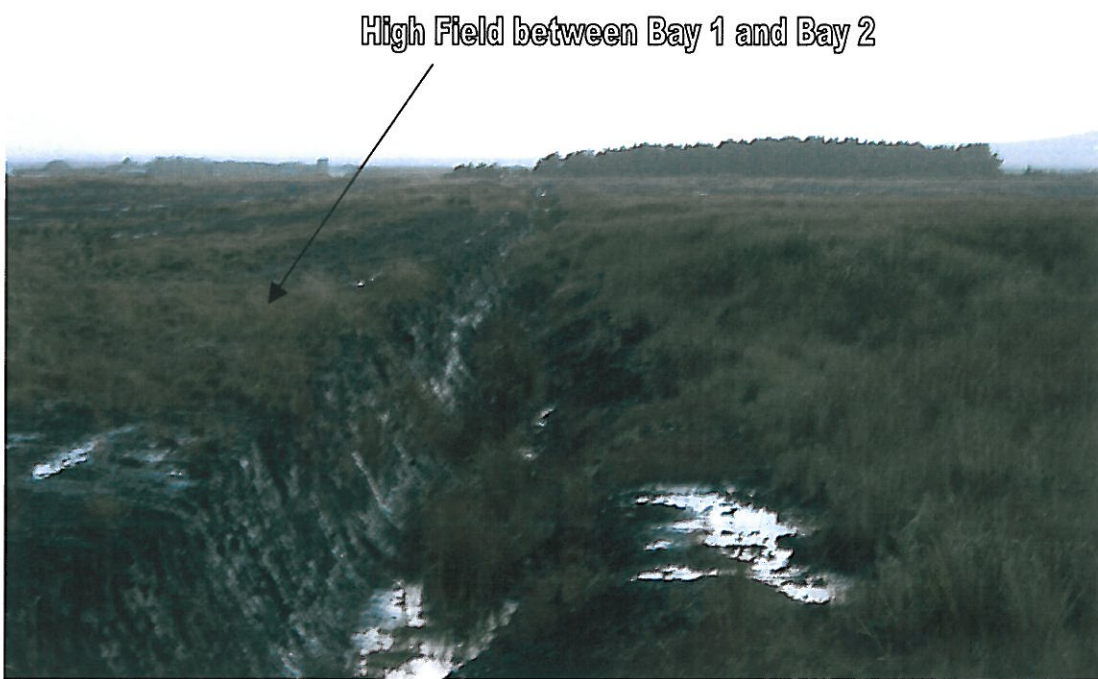
Bay 2 North End partly filled with peat in 2005

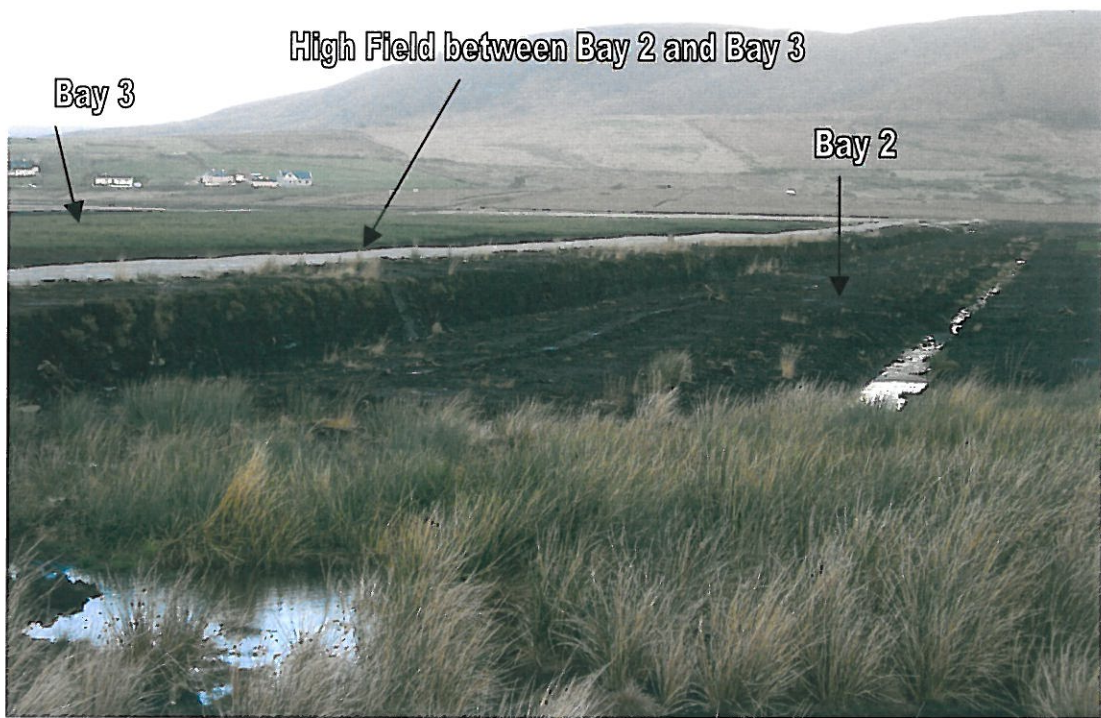
Southern end of Bay 2 empty

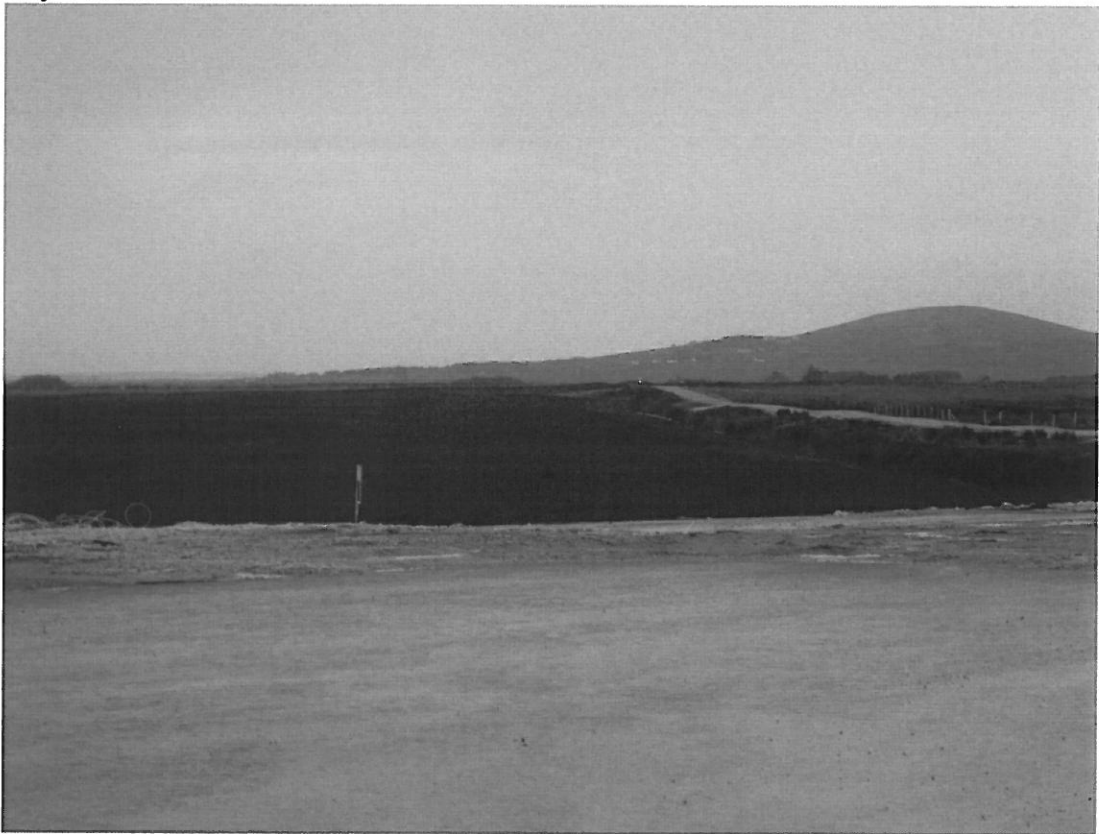
Bay 5 Heavily vegetated

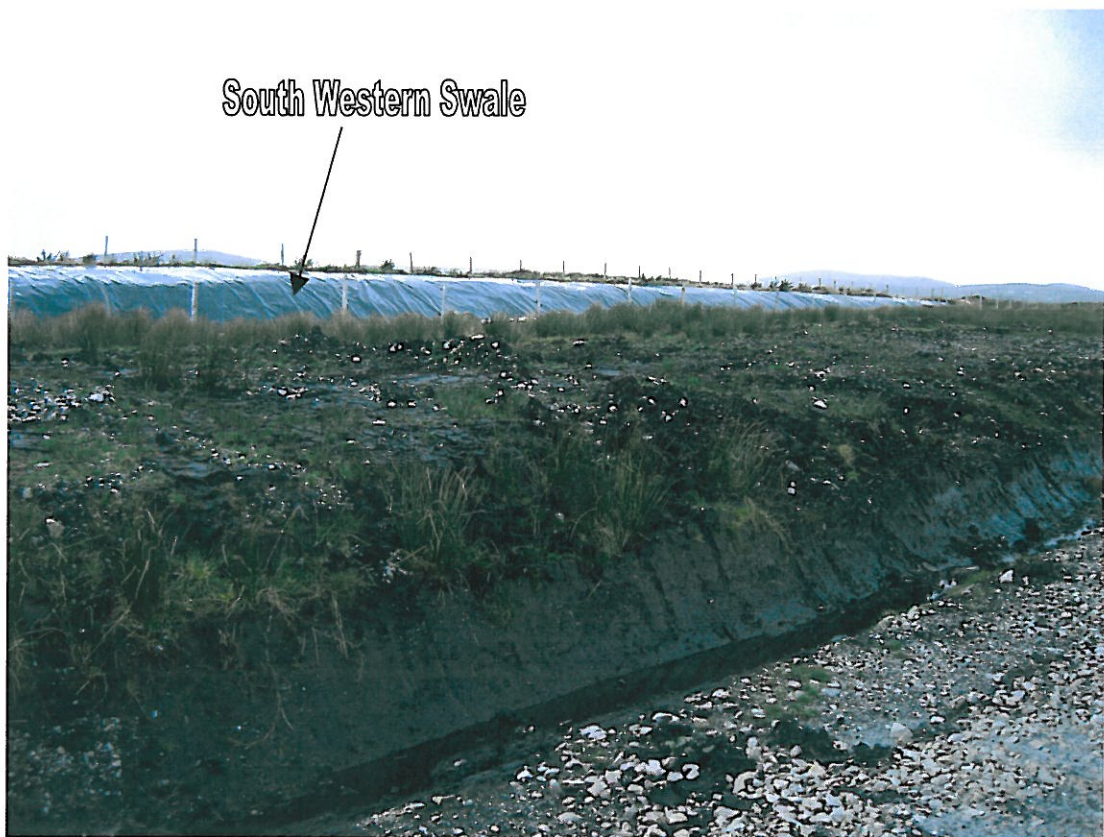
Bay 5 South Western Boundary

The outer perimeter of the deposition area was inspected and no evidence of instability was observed

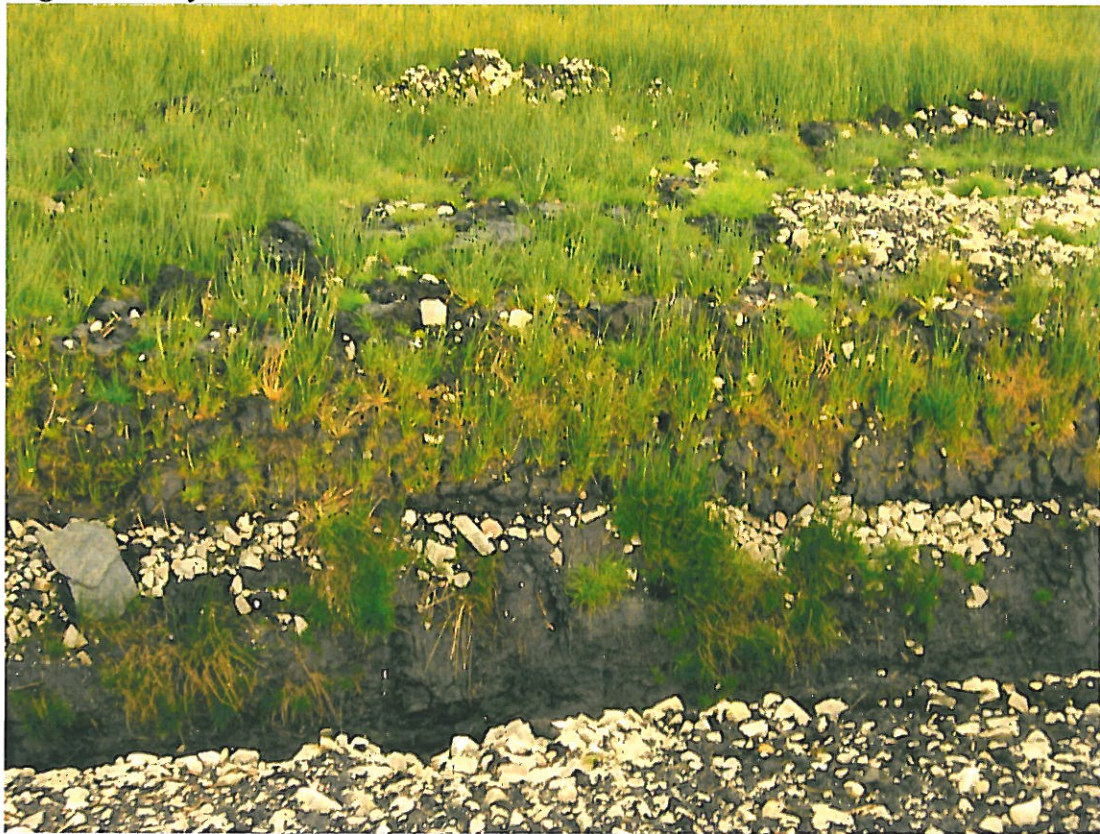
Condition of deposited Peat

The Peat placed in Bays 2,3,4 and 5 is at it's maximum thickness, about 1.5m thick, in the centre of each of the bays thinning towards it's margins. The deposited peat is not loading the internal high fields. The upper surface of the peat is dry, firm with numerous desiccation cracks. The peat is densely covered by rushes, which have colonised the imported peat. V-ditch drains have been excavated in the

The peat within each bay is contained by the high fields and there was no evidence of any movement or slumping of the deposited peat

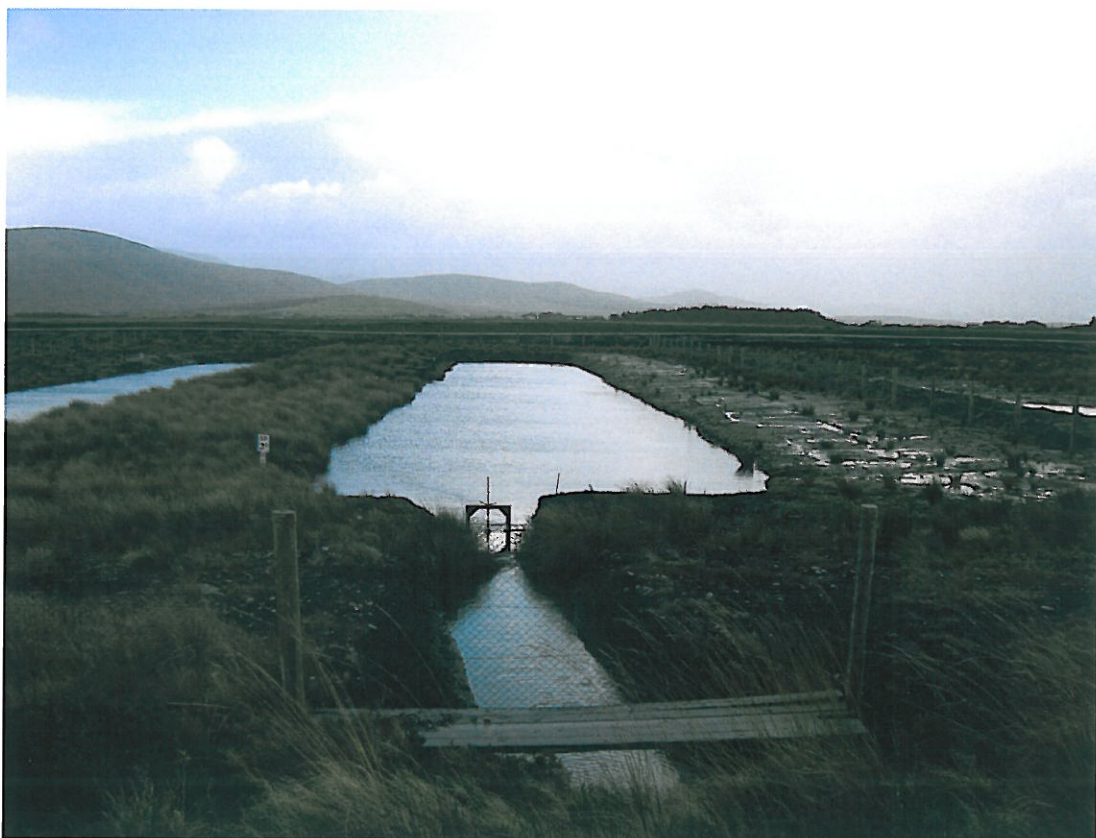
Settlement Ponds North Eastern End Bay 6

Two pairs of rectangular settlement ponds are present in Bay 6 and North East of Bay 6. The exposed side walls of the ponds are in good condition and no indication of distress in the peat was noted

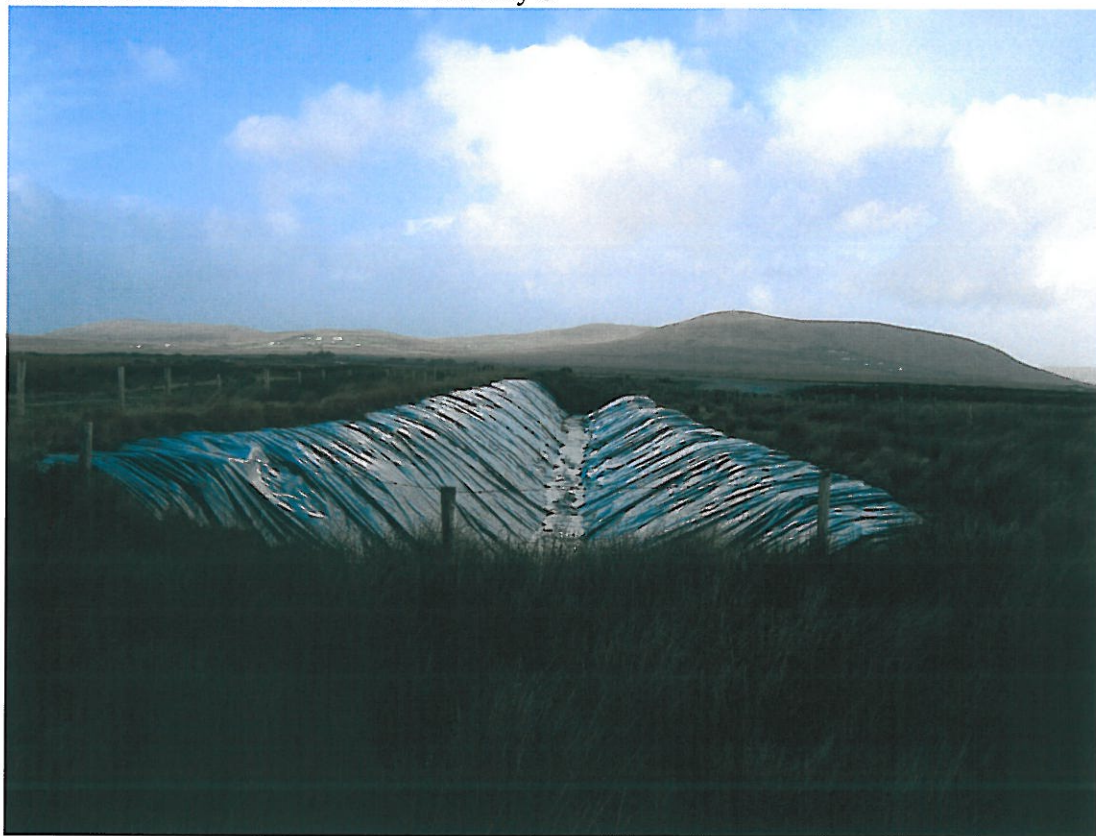
South Western Swale

This is a deep wide drain lined with plastic sheeting at the south-western end of the Bays. No bulges or cracks in the plastic liner were observed and no tension cracks were present at the crests of the Swale.

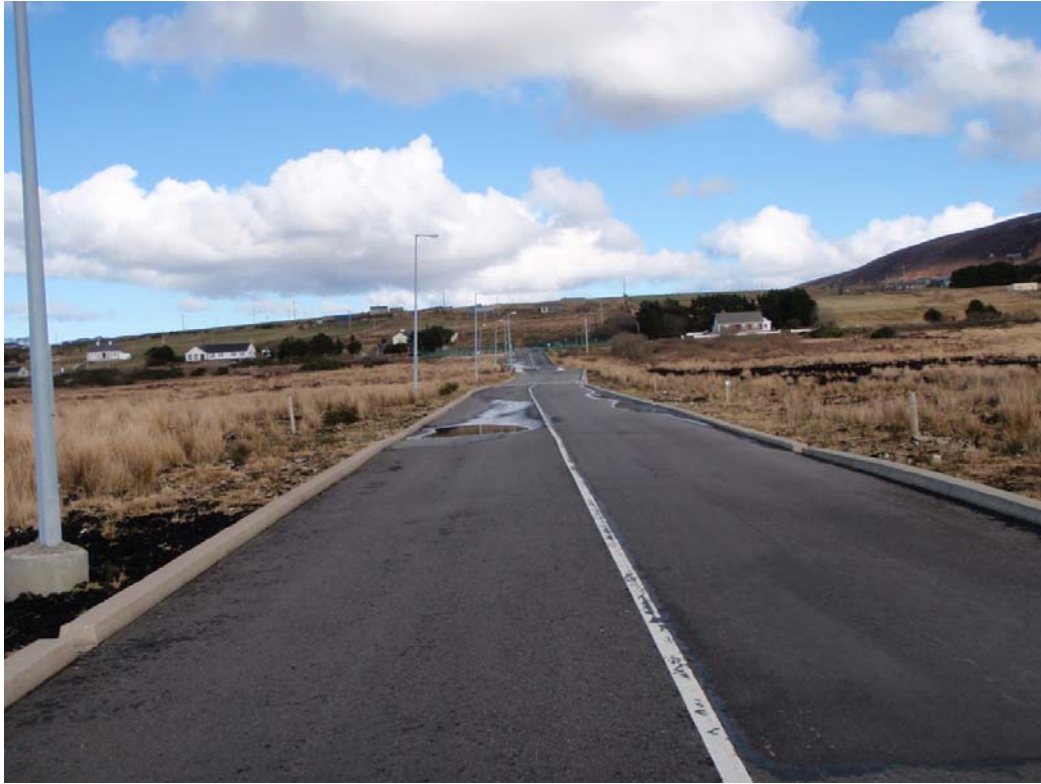
Condition of Access Road from R313

Cracks and localised wheel ruts are evidence of damage to the wearing coarse were present particularly on the east side of the road. Slight rotation of the lighting columns was also observed

The access road has proved fit for purpose during the importation of peat and is in a satisfactory condition to provide continuing access for any further works

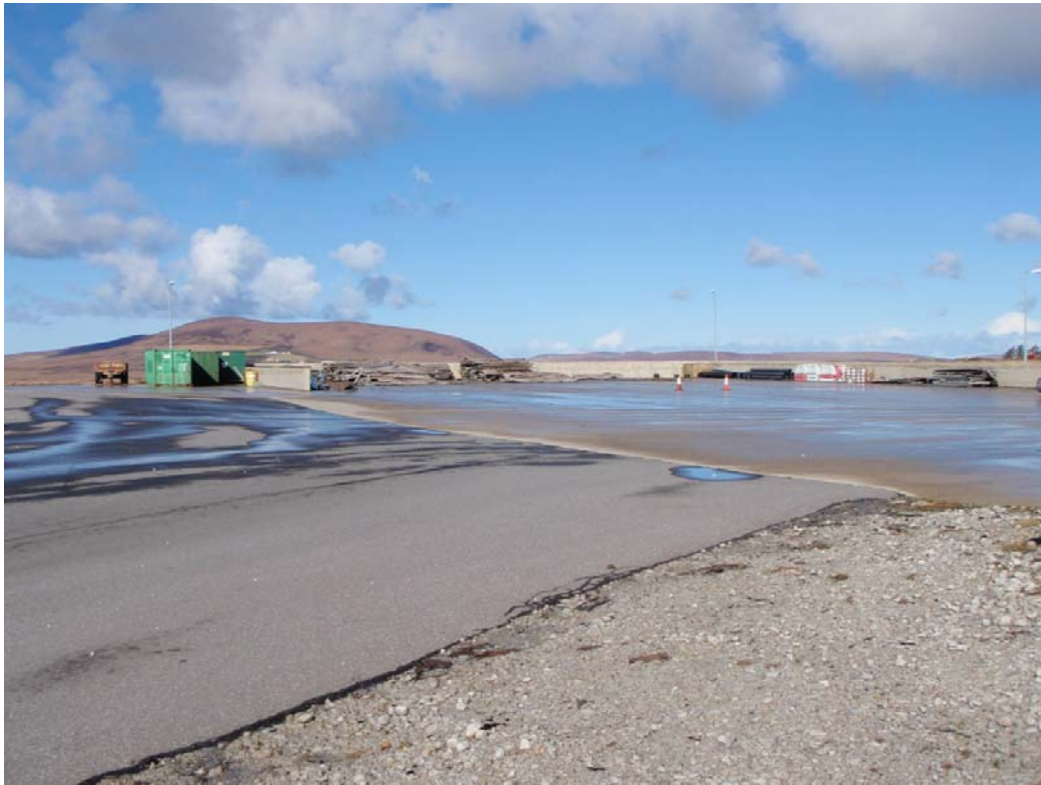
Peat Reception Area

These structures have been founded directly onto mineral soil. No evidence of distress to the slab and associated buildings was observed

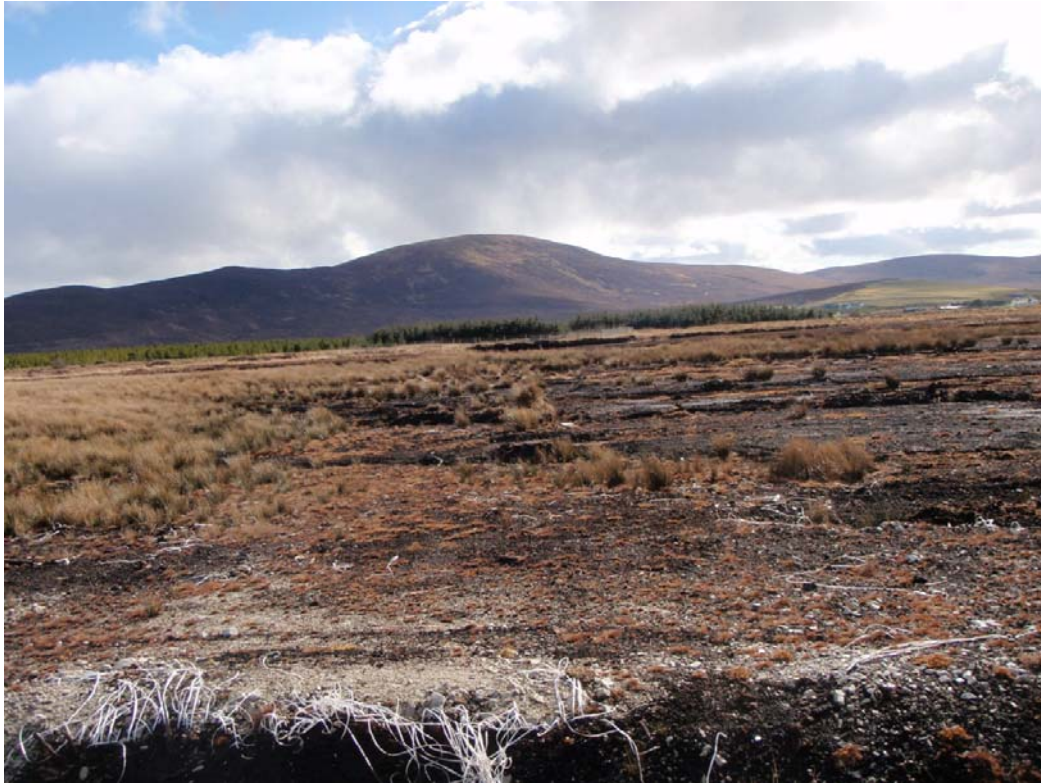
Bay 2 Partly Filled with peat

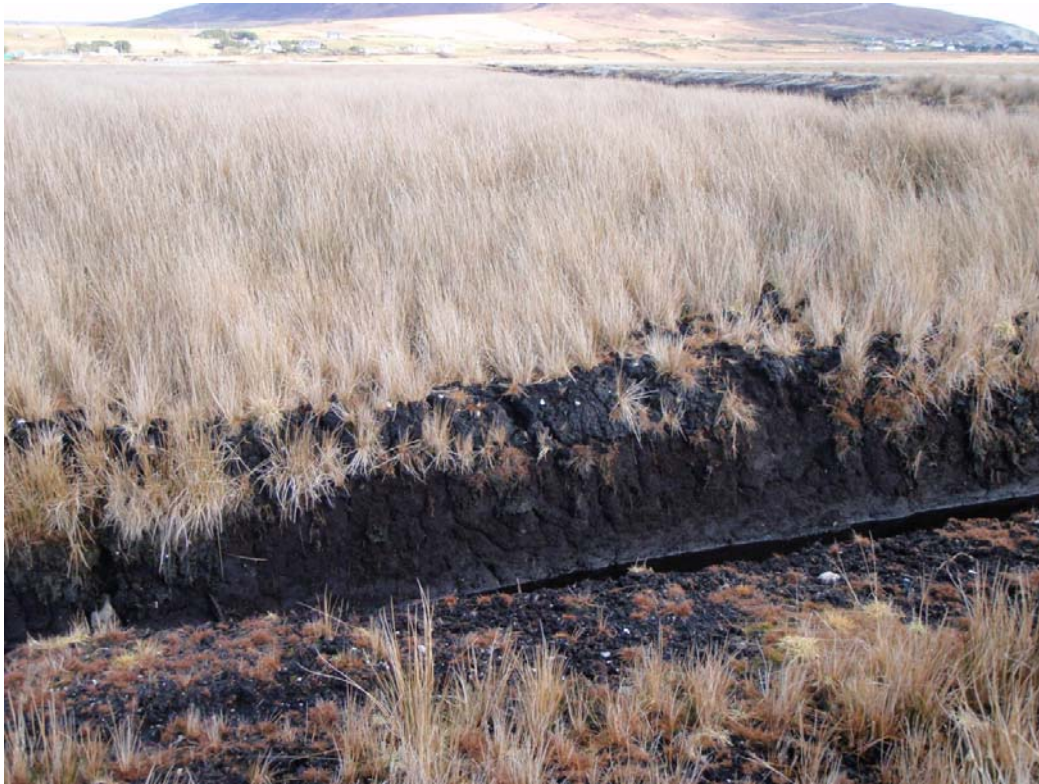
Condition of Deposited Peat

The Peat placed in Bays 2,3,4 and 5 is a maximum of 1.50m thick in the centre of each bay thinning to less than about 0.50m toward it's margins. The deposited peat is not loading the internal high fields. The upper surface of the peat is dry, firm with numerous desiccation cracks. The peat is densely covered by rushes which have colonised the imported peat. V-ditch drains have been excavated in the deposited peat which are linked to deep edge drains at the base of each high field. V-Ditch drains are also present on the north and south of each bay. The drains are open and functioning well in each Bay

The peat within each bay is contained by the high fields and there was no evidence of any significant movement or slumping of the deposited peat

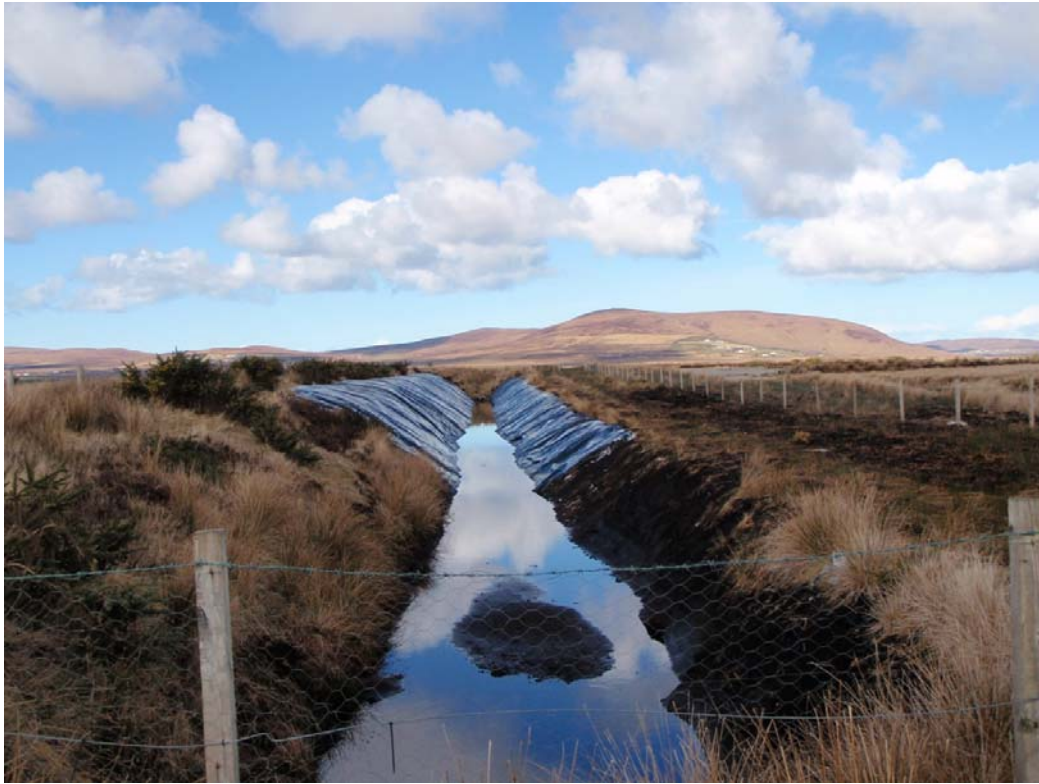
This is a deep wide drain lined with plastic sheeting at the south western end of the Bays. No bulges or cracks in the plastic liner were observed and no tension cracks were present at the crests of the Swale.

Partly Lined SW Swale South of Bay 5

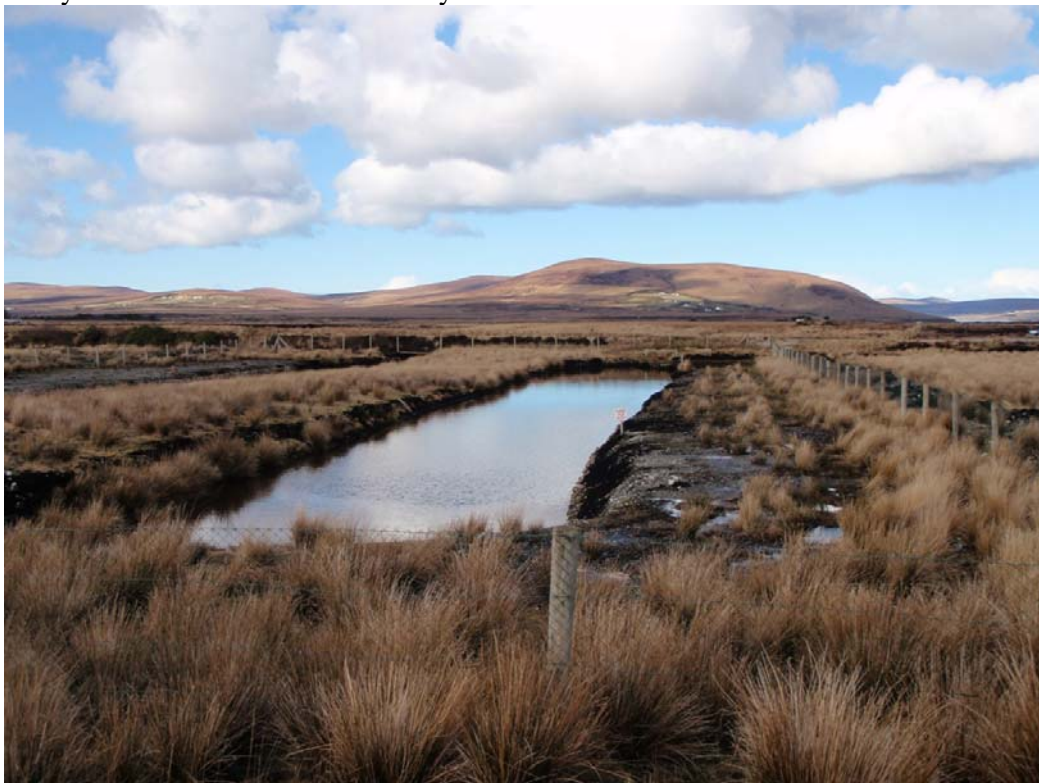
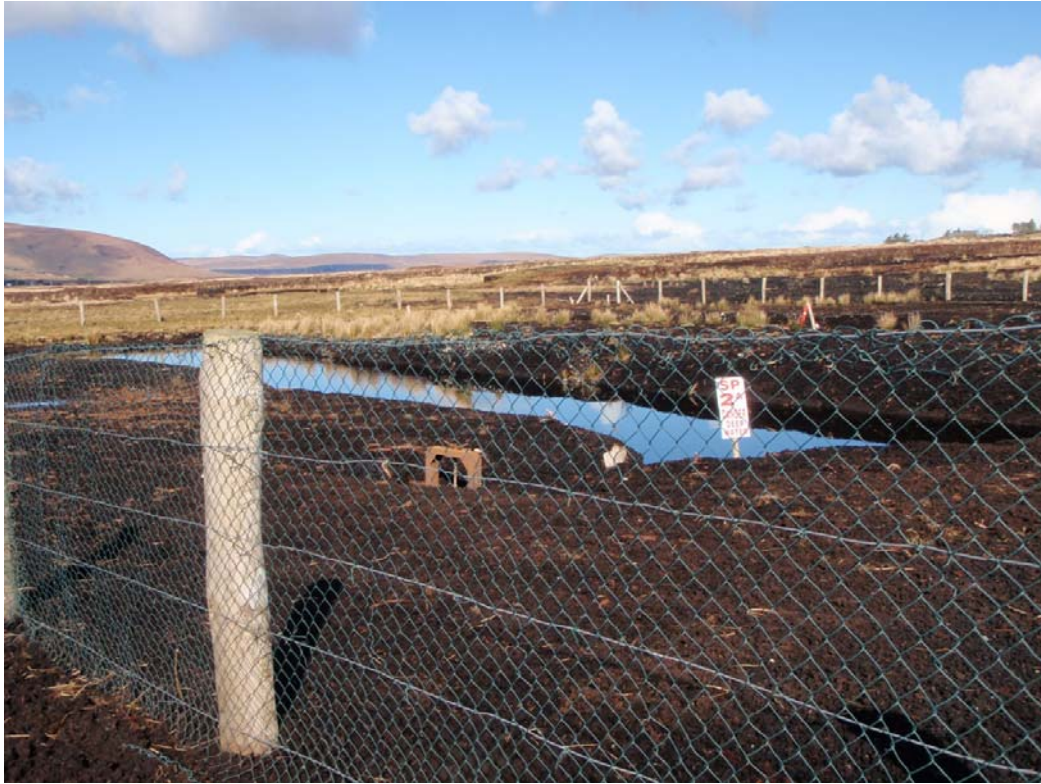
Two pairs of rectangular settlement ponds are present in Bay 6 and North East of Bay 6. The exposed side walls of the ponds are in good condition and no indication of distress in the peat was noted

Settlement Ponds Bay 6

Settlement Ponds NE of Bay 6
