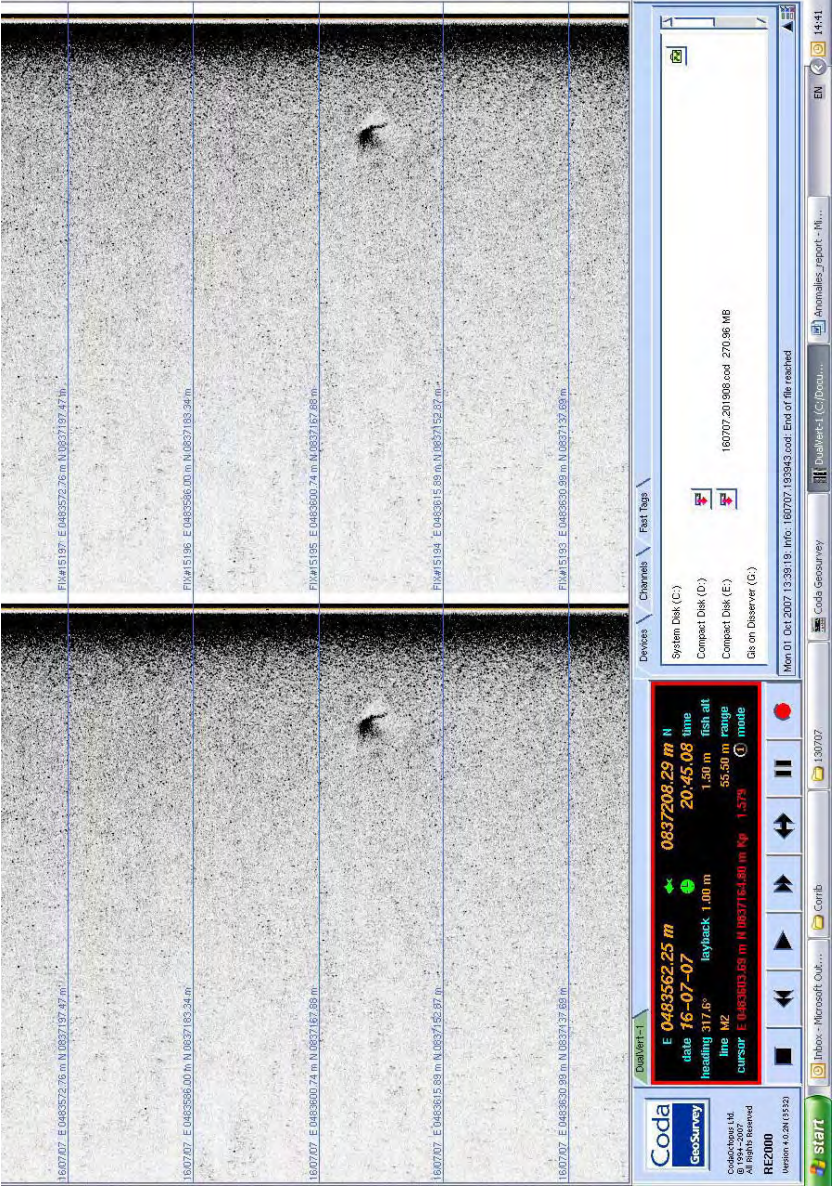
Anomaly No.	Fix No.	ITM Easting	ITM Northing	ING E	ING N	WGS84 Lat N			WGS84 Long W			Description
16	14873	483594.07	837159.93	83617.756	337154.586	54	16	11.9429	9	47	13.67148	Localized small anomaly on seabed, debris
See anomaly 17, which is the same location												
17	15194	483597.76	837154.03	83621.447	337148.685	54	16	11.7551	9	47	13.45939	Localized anomaly on sandy featureless bed.

<p>Diver Inspection Identification: Anomalies 16 and 17 are the same object observed from different angles. The object is a large Fragment of Iron, machine part, with scour hole and snagged mono-filament netting, Plate 51.</p>

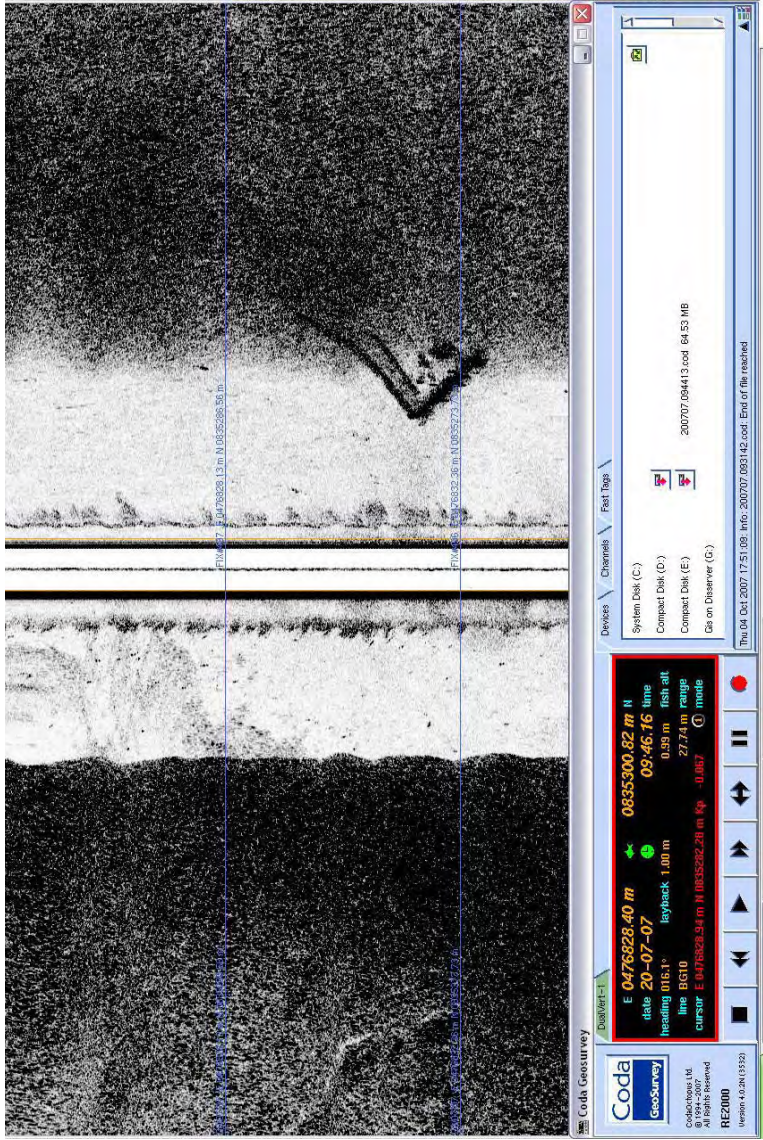
Anomaly No.	Fix No.	ITM Easting	ITM Northing	ING E	ING N	WGS84 Lat N			WGS84 Long W			Description
20	406?	476839.59	835277.99	76861.864	335272.233	54	15	5.40736	9	53	23.98381	Striking anomaly on clay bed. Straight side 5.64m long with three curving ribs extending on SW side, the longest measuring 8.46m long. Definite high potential

<p>Diver Inspection Identification: Anomalies located outside survey area, near Ballyglass Lighthouse.</p>

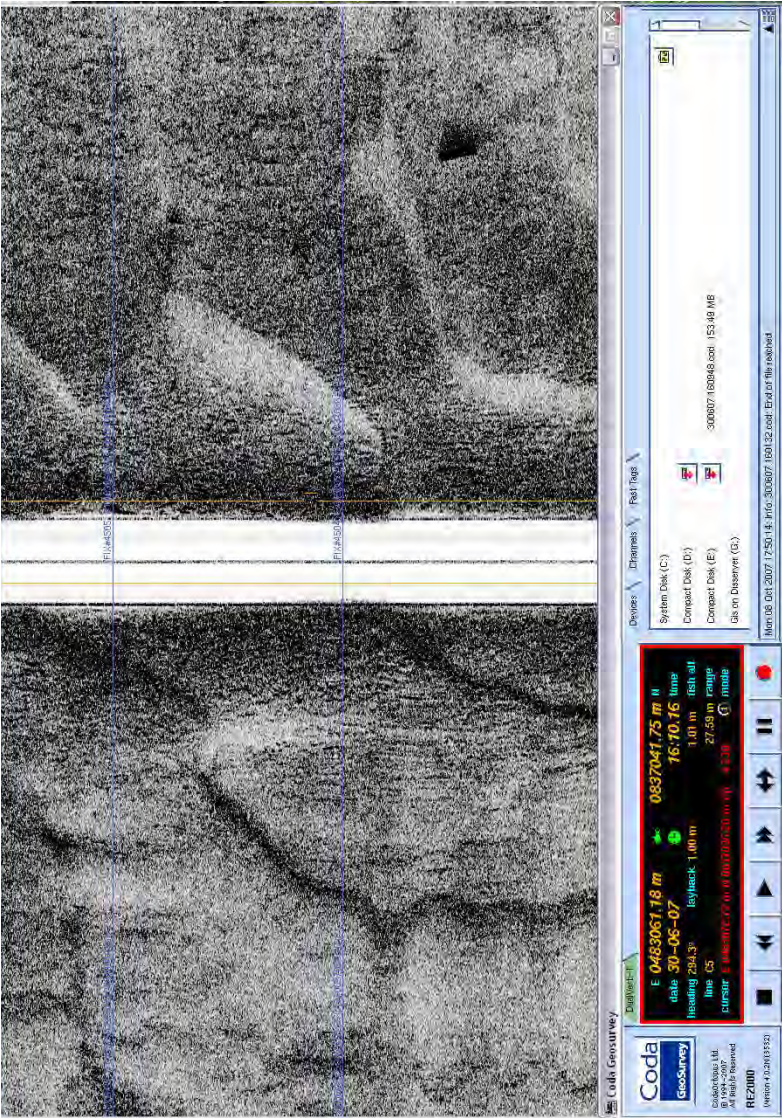
Anomaly No.	Fix No.	ITM Easting	ITM Northing	ING E	ING N	WGS84 Lat N			WGS84 Long W			Description
25	4504	483087.75	837049.47	83111.329	337044.102	54	16	7.95594	9	47	41.48505	c. 1m long narrow anomaly on sand-wave bed. Debris.

<p>Diver Inspection Identification: Dog Hutch within large scour hole, Plate 52.</p>

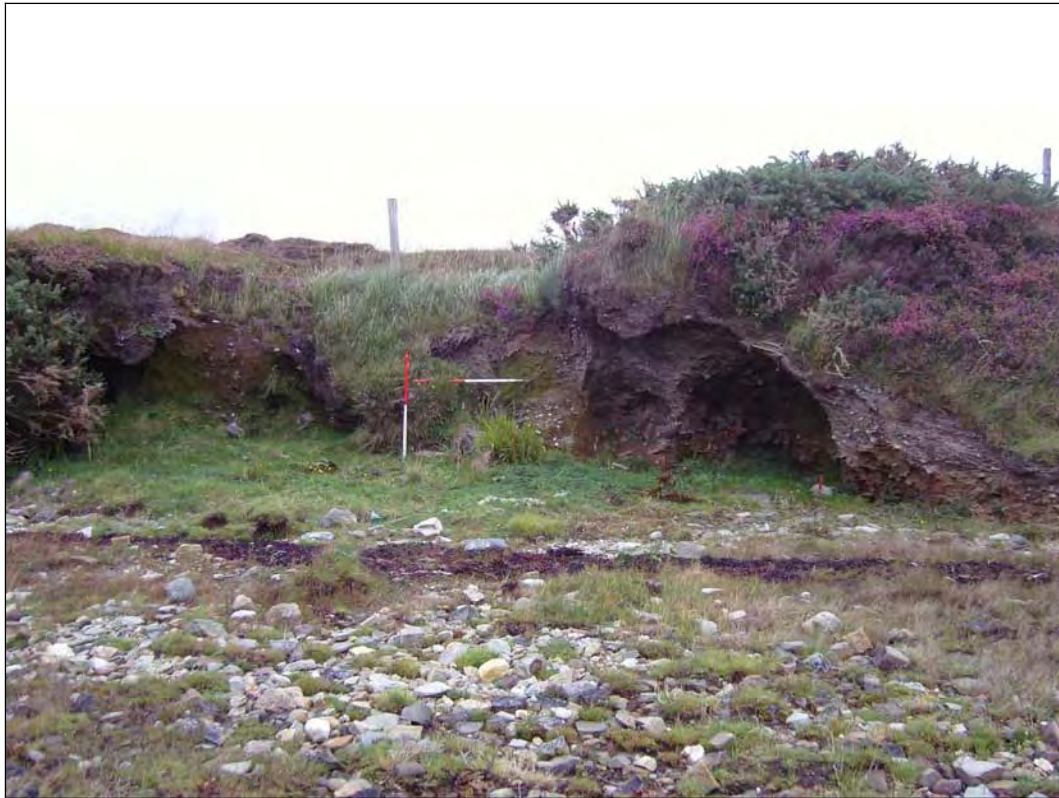
Plate 12: North-facing view of upper foreshore at TRP 5; note erosion of bank structure (1m scale).

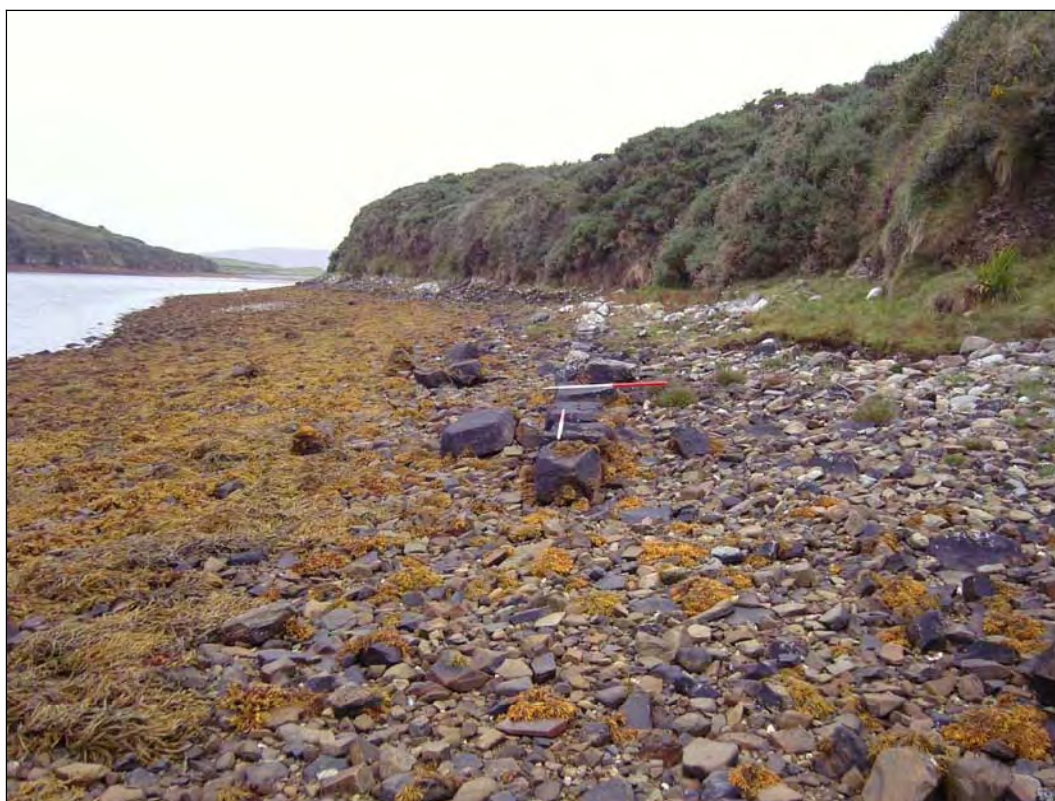
Plate 46: West-facing view of Feature 1, located along the upper limit of the inter-tidal zone (1m scale ranging rods).

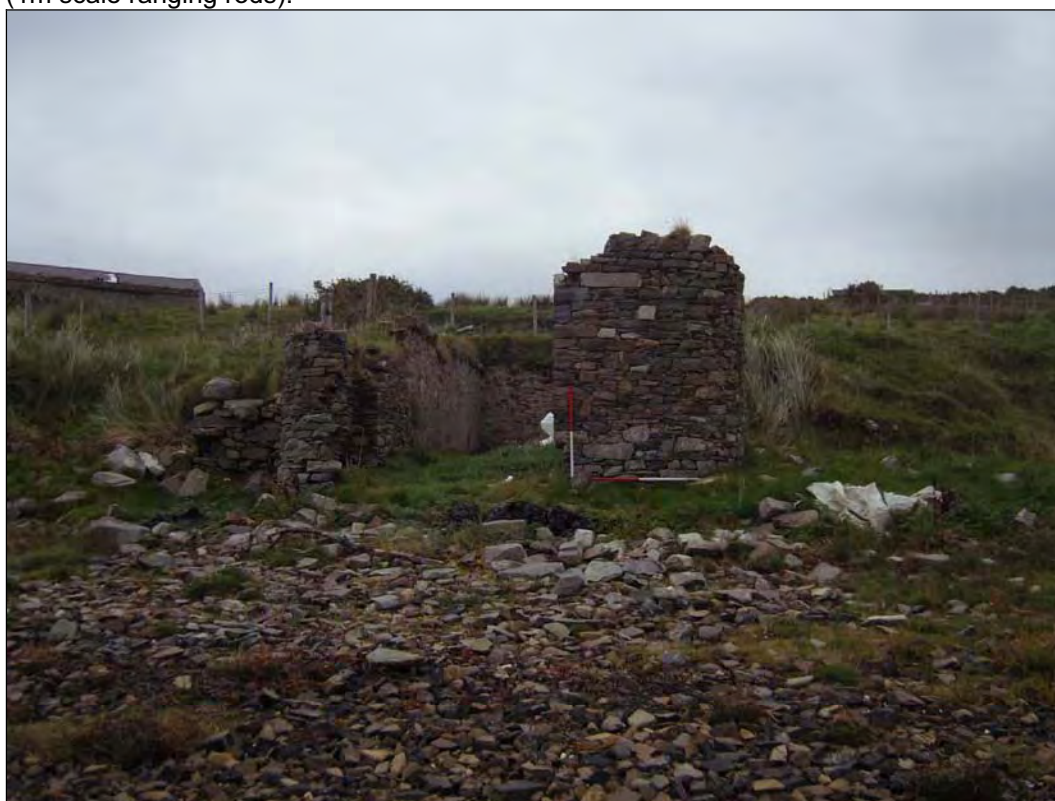
Plate 47: North-facing view of Feature 2, ruined boat house, located along the upper foreshore (1m scale ranging rods).

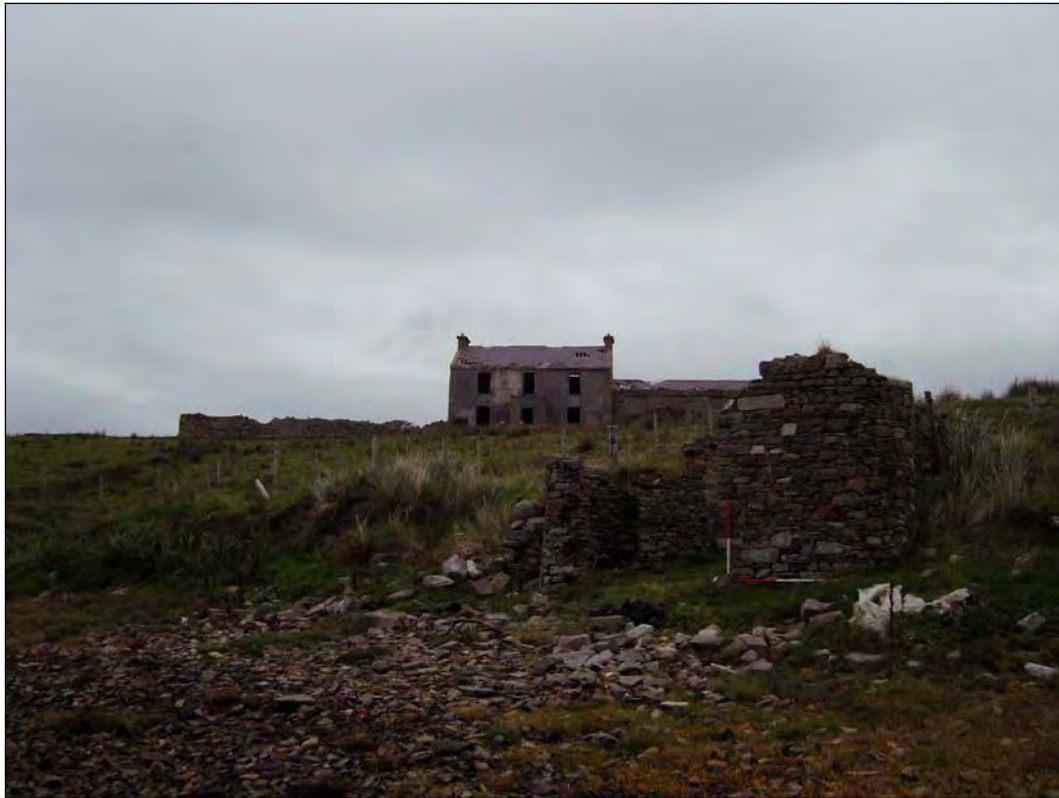
Plate 48: North-facing view of Feature 2, ruined boat house and associated dwelling (1m scale ranging rods).

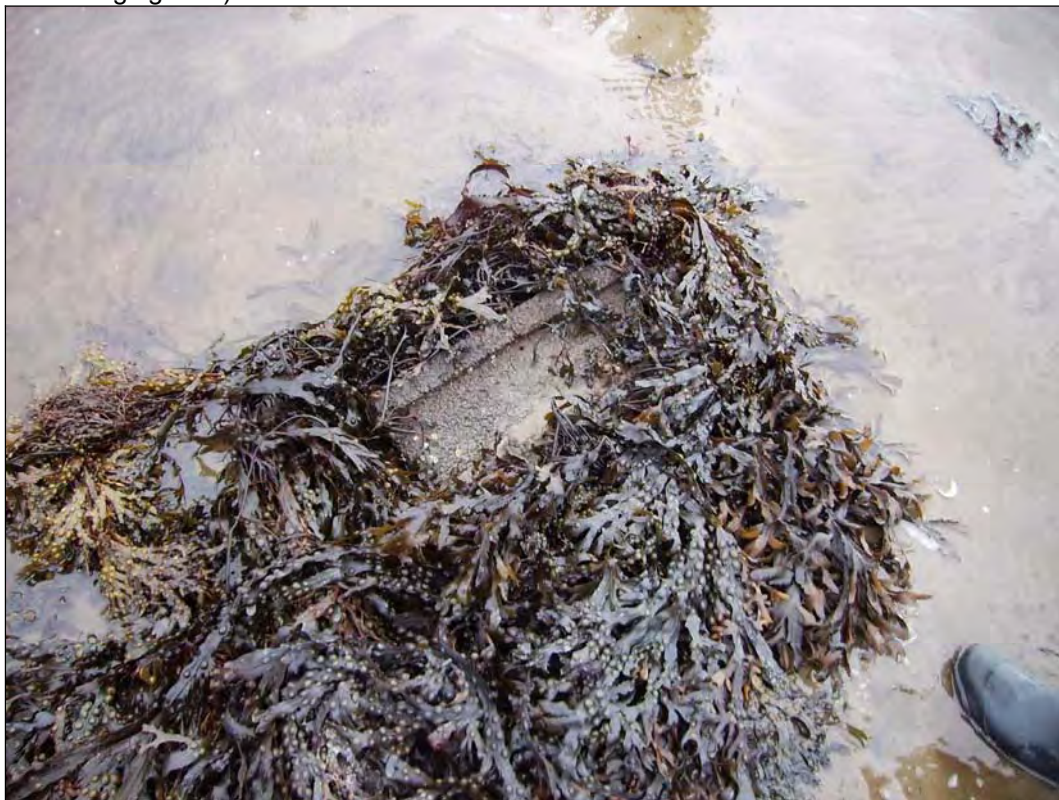
Plate 49: Shot of SS12, Seaweed covered Breeze-block and small scour hole.

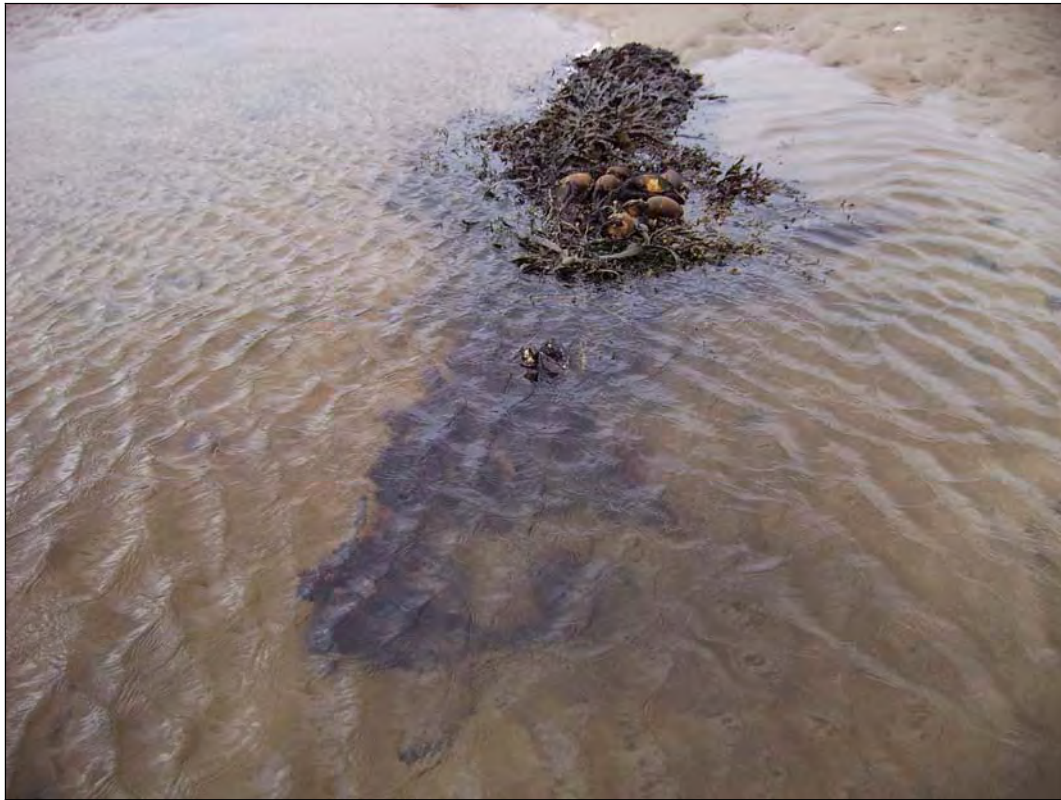
Plate 50: Shot of SS16, Fragment of Iron (machine part) with scour hole and snagged mono-filament netting

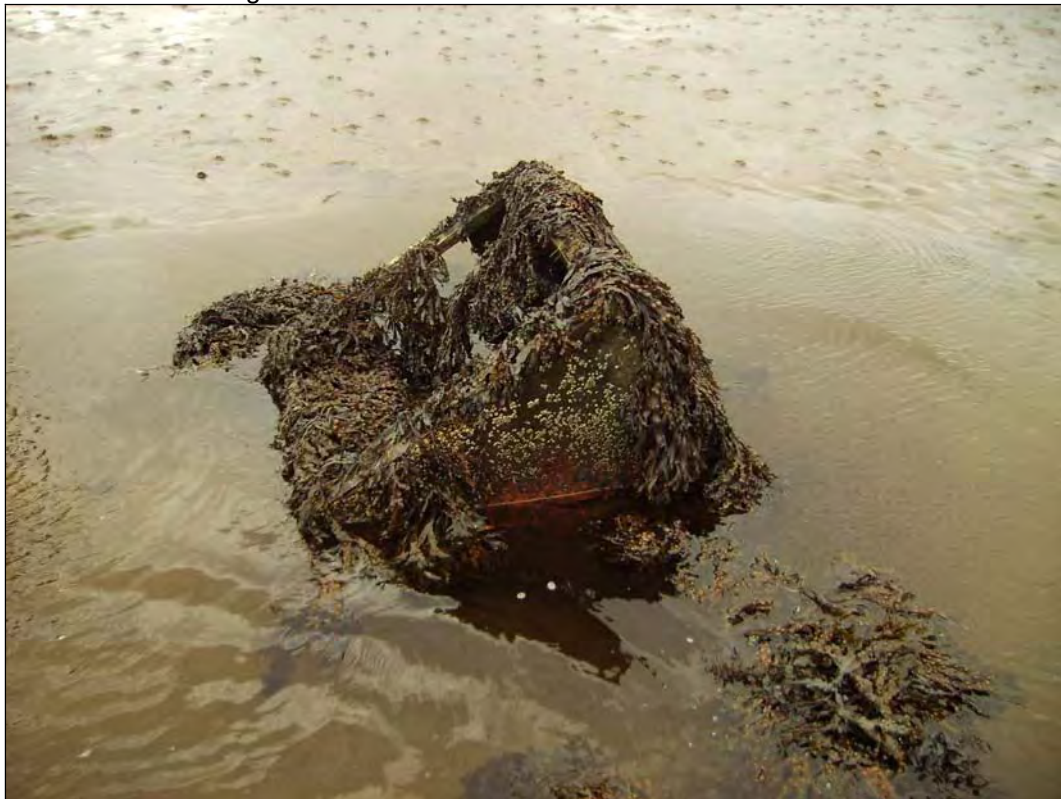
Plate 51: Shot of SS25, Dog Hutch located within large scour hole.
